Lamwo Mass Casualty Investigation Report (MCI)

Activity: Lightning mass casualty investigation (MCI)

Location: Lamwo Refugee Settlement, Lamwo District, Uganda

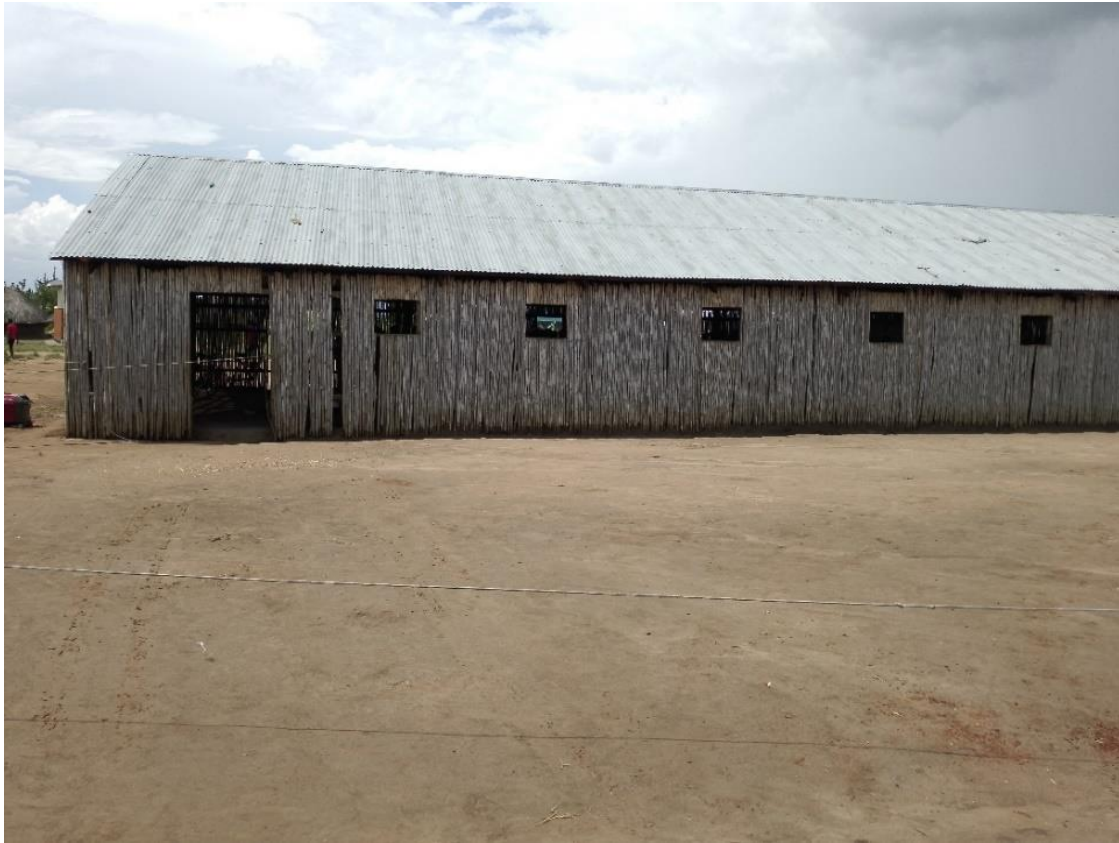
1. **Structure Front View (South Side):**

The affected structure, typically used as a distribution centre, was made of bamboo walls and an iron sheet roof, with a bare soil floor. The front (south side) and back (north side) of the structure showed minor physical damage from the lightning strike.

Depicts the area hit by lightning.

The structure lacked lightning protection, which could have prevented or minimized the impact of the strike.

1. **Seek Shelter:** Immediately shelter in fully enclosed buildings at the first sign of thunder or lightning. Though this is not sufficient without standardized lightning protection, but it may help slightly.
2. **Install Lightning Protection Systems in major buildings:** To save lives and prevent such incidents. This may be done relatively easily if the metal roofs are continuous, downconductors are added on all 4 corners with earthing rods. This is not perfect, but it is much less expensive than a complete lightning protection system.
3. **Public Sensitization:** Eradicate myths and misconceptions about lightning through education.
4. **Stay Indoors:** Remain indoors until 30 minutes after the last thunder is heard
5. **Avoid Open Areas and Tall Objects:** Stay away from trees and utility poles.

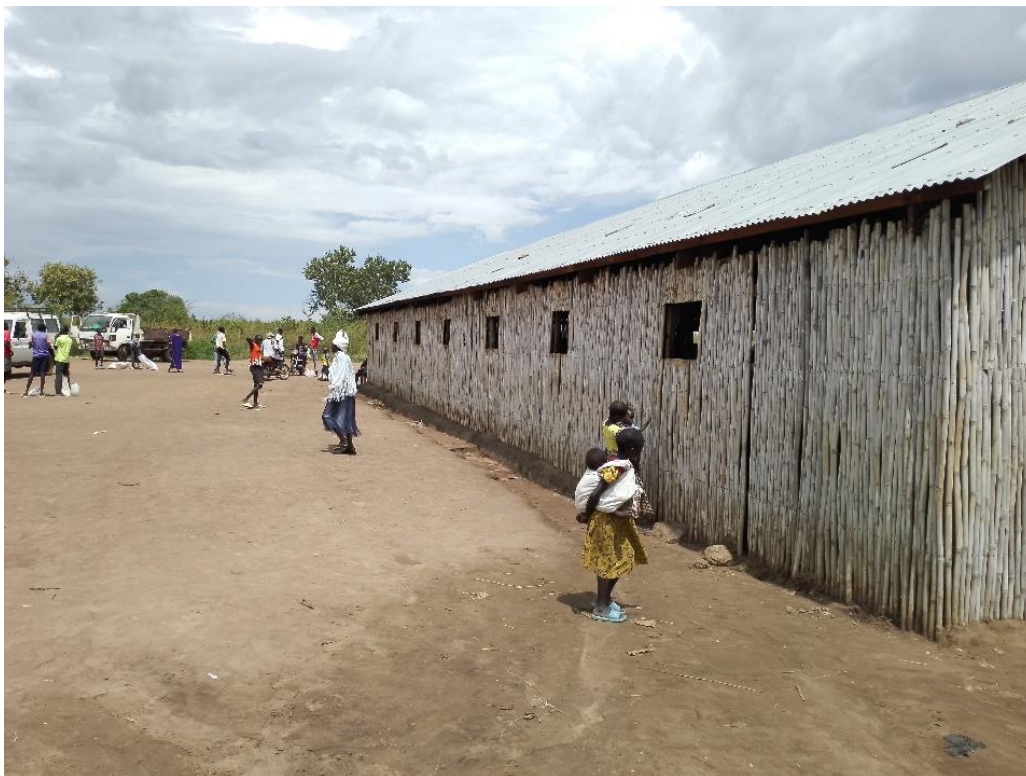
2. Structure Back View (North Side):

Shows new minor breakages in the bamboo to the right side of the rightmost window..

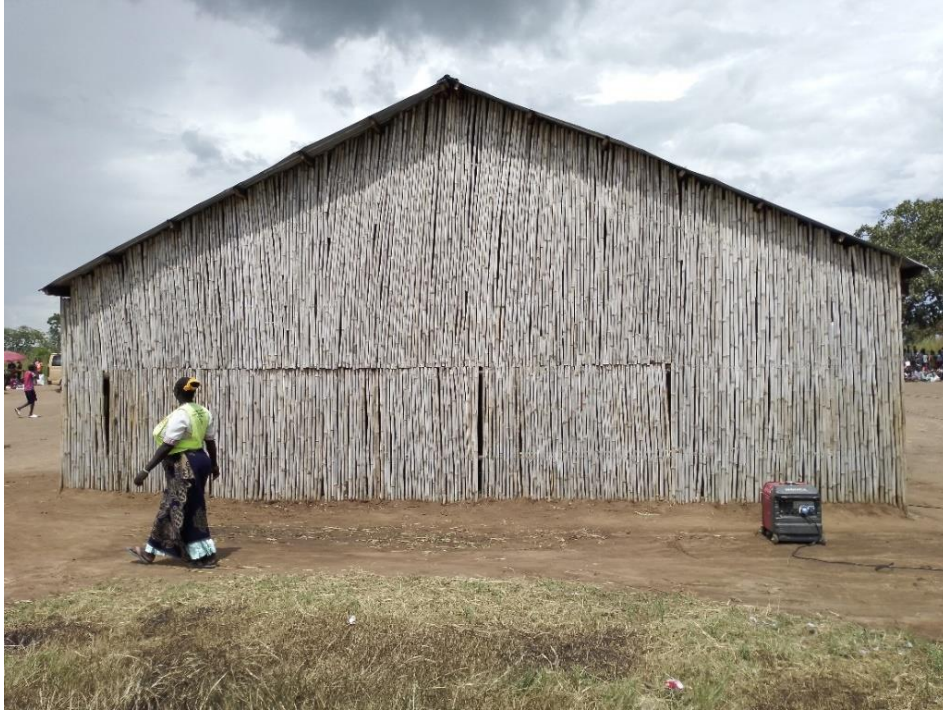
3. East Side of the Structure:

No significant damage.

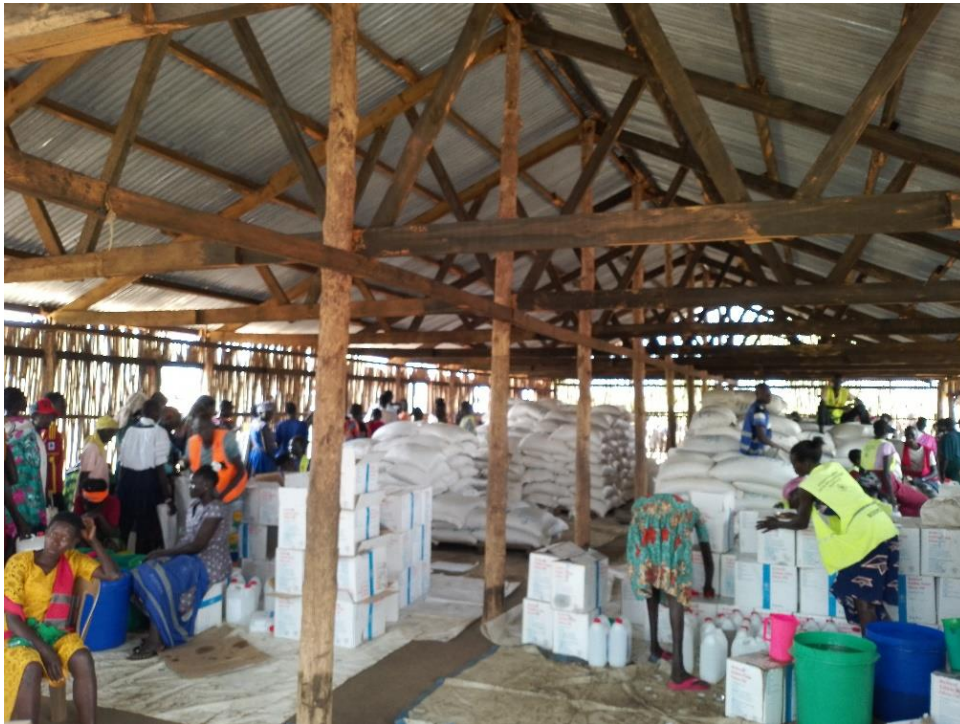
4. Internal Structure:

Damage to the wooden poles and other areas inside the structure.

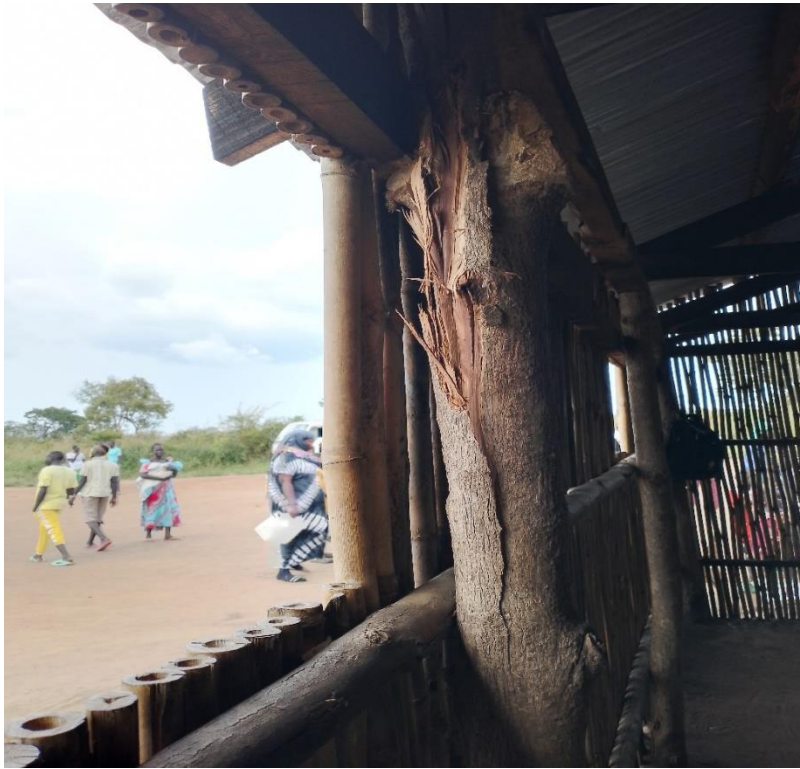
5. Other damaged parts of the structure

This provides a clear view of the affected area, featuring the wooden structure where the pole cracked.

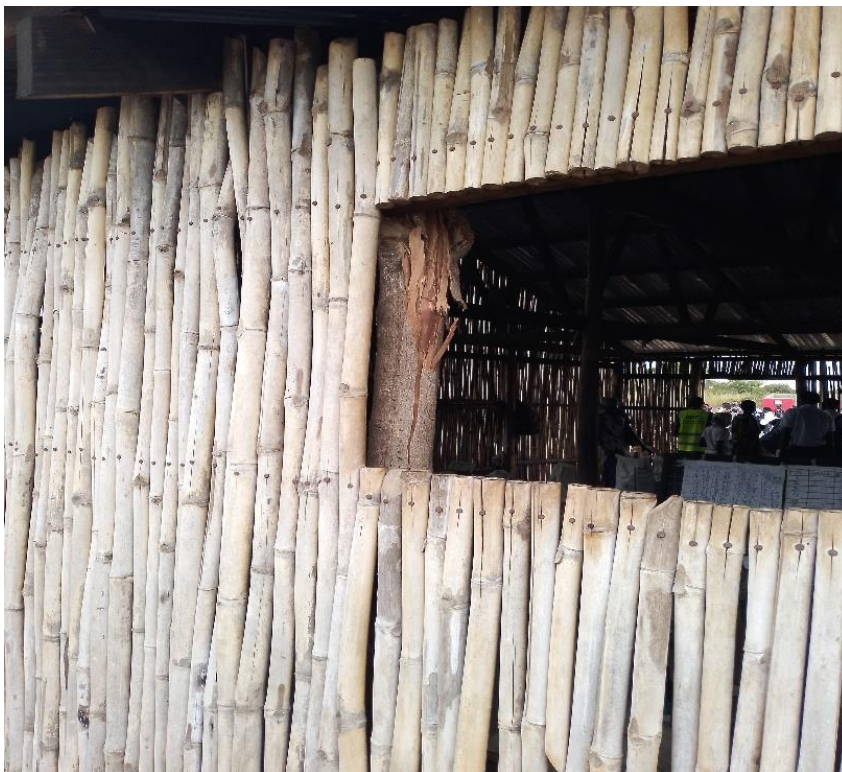
View from outside the structure of the significantly affected area.
